NATIONAL TRANSPORTATION SAFETY BOARD

MATERIALS LABORATORY FACTUAL REPORT

Report No. 10-122

Place : Waxahachie, Texas
Date : January 23, 2010
Vehicle : Tecnam P2002
NTSB No. : CEN10FA107
Investigator : Tom Latson

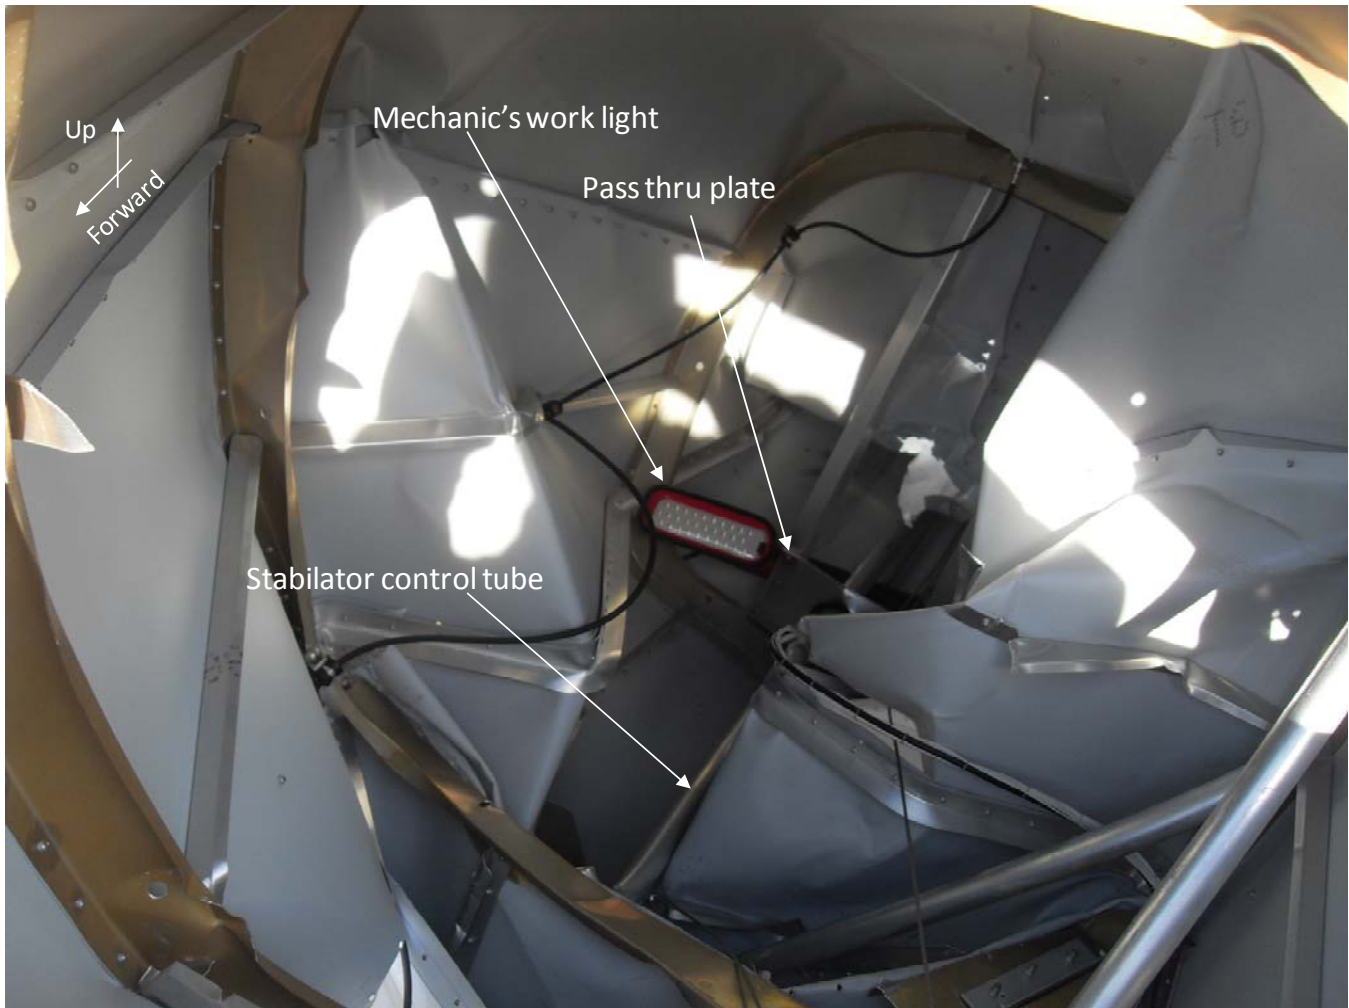
Figure 1 shows a view looking aft of the inside of the fuselage tail section. As indicated in figure 1, a mechanic's work light is observed in the general proximity of the stabilator control tube and the pass thru plate. The as-received components from the aircraft wreckage are shown in Figure 2. The sketch in Figure 3 depicts the general location of the submitted pieces on the aircraft.

Figure 1 View looking aft of the inside of the aircraft tail section after the accident. Note the presence of a mechanic's work light located near the bulkhead with the stabilator pass thru plate.

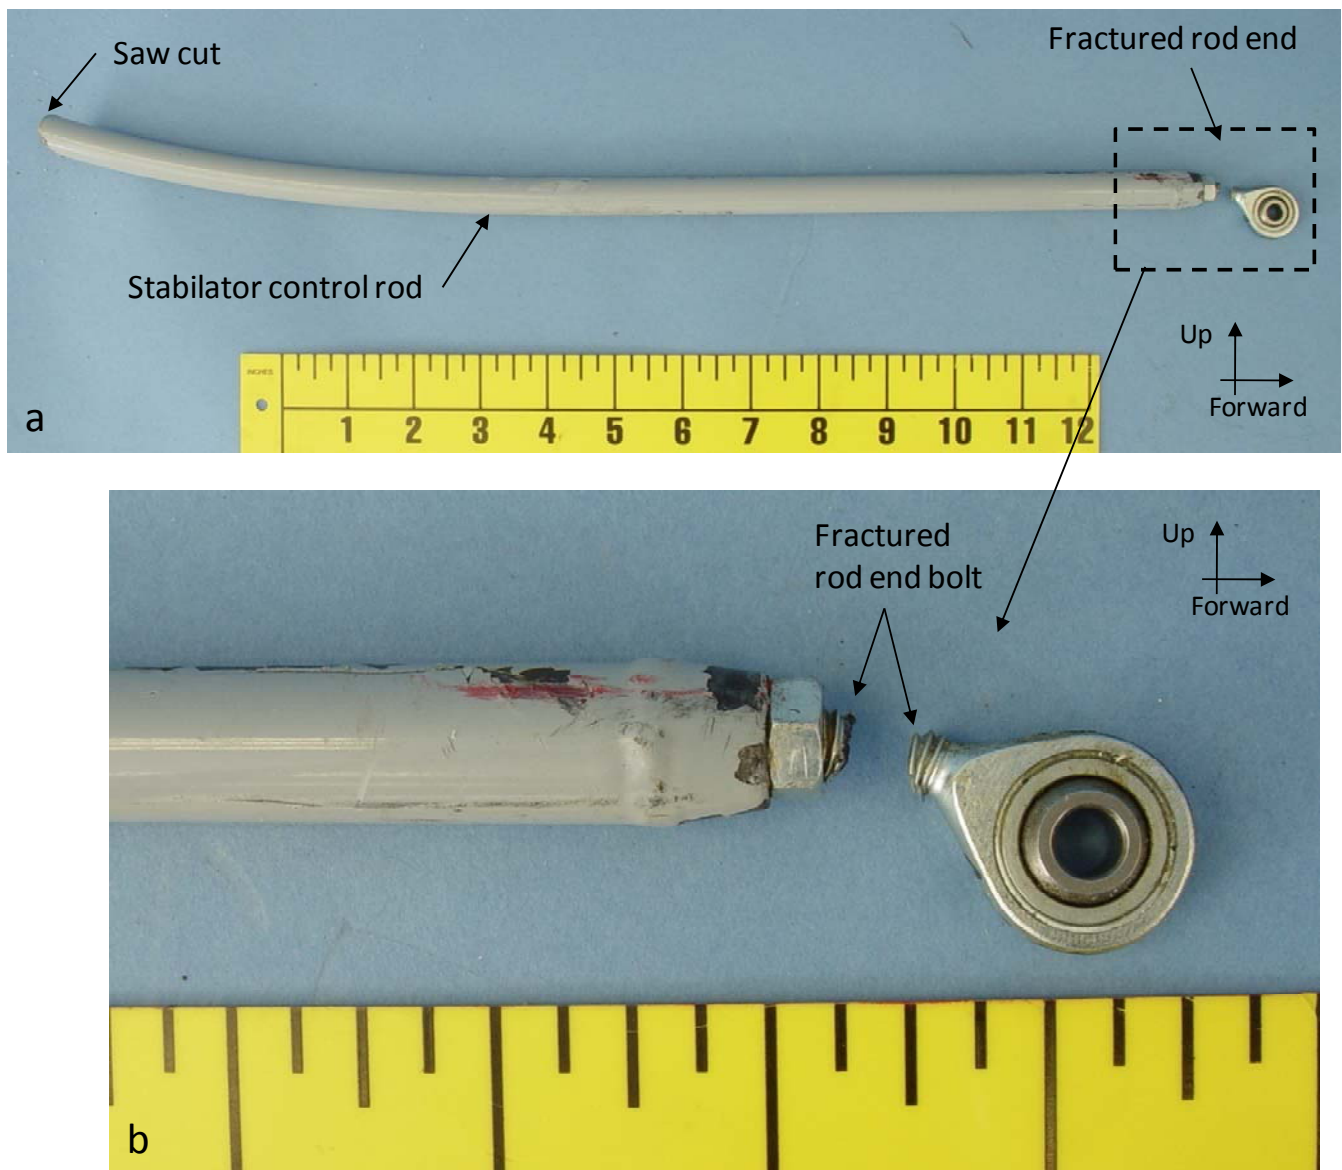
Detailed images of the forward stabilator rod in Figure 2a are shown in Figure 4. The fracture features and thread damage indicate that the rod end fractured in ductile overstress due to downward cantilever bending.

Figure 4 Views of the forward stabilator control rod. a) forward stabilator control rod with fractured rod end. b) close up view of the fractured rod end. The fracture features and thread damage indicate that the rod end fractured in ductile overstress due to downward cantilever bending.

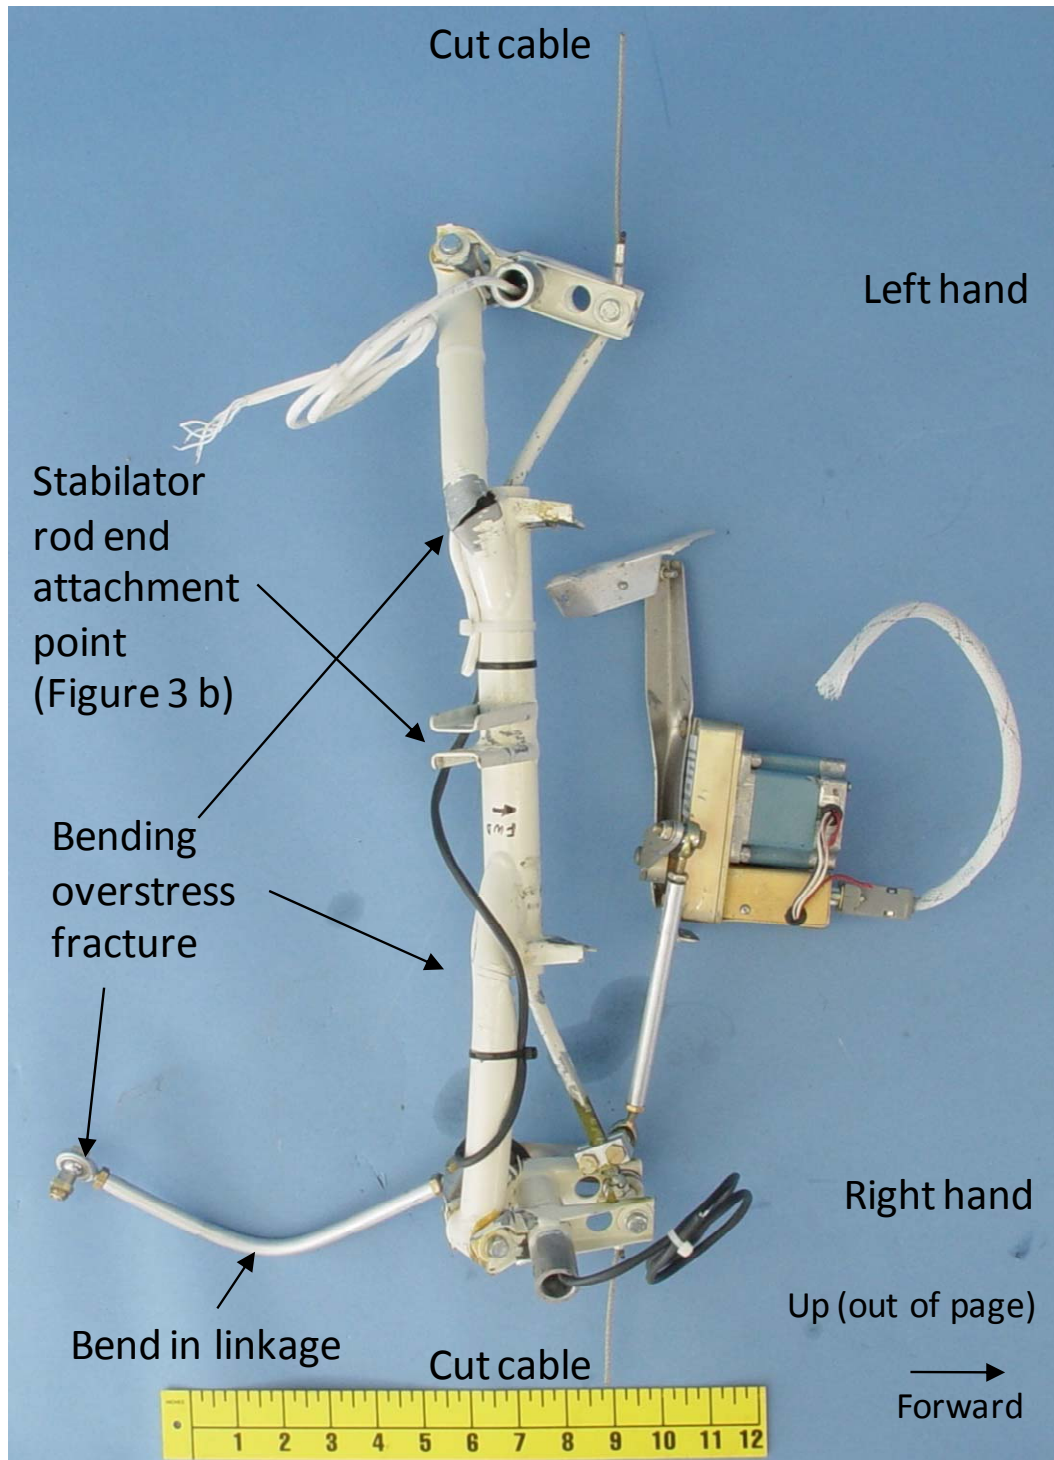
The forward control mixing unit is shown in Figure 5. Three areas of bending overstress fracture are indicated in the figure. A bend in a linkage is also indicated.

Figure 5 Forward control mixing unit showing areas of bending overstress fracture.

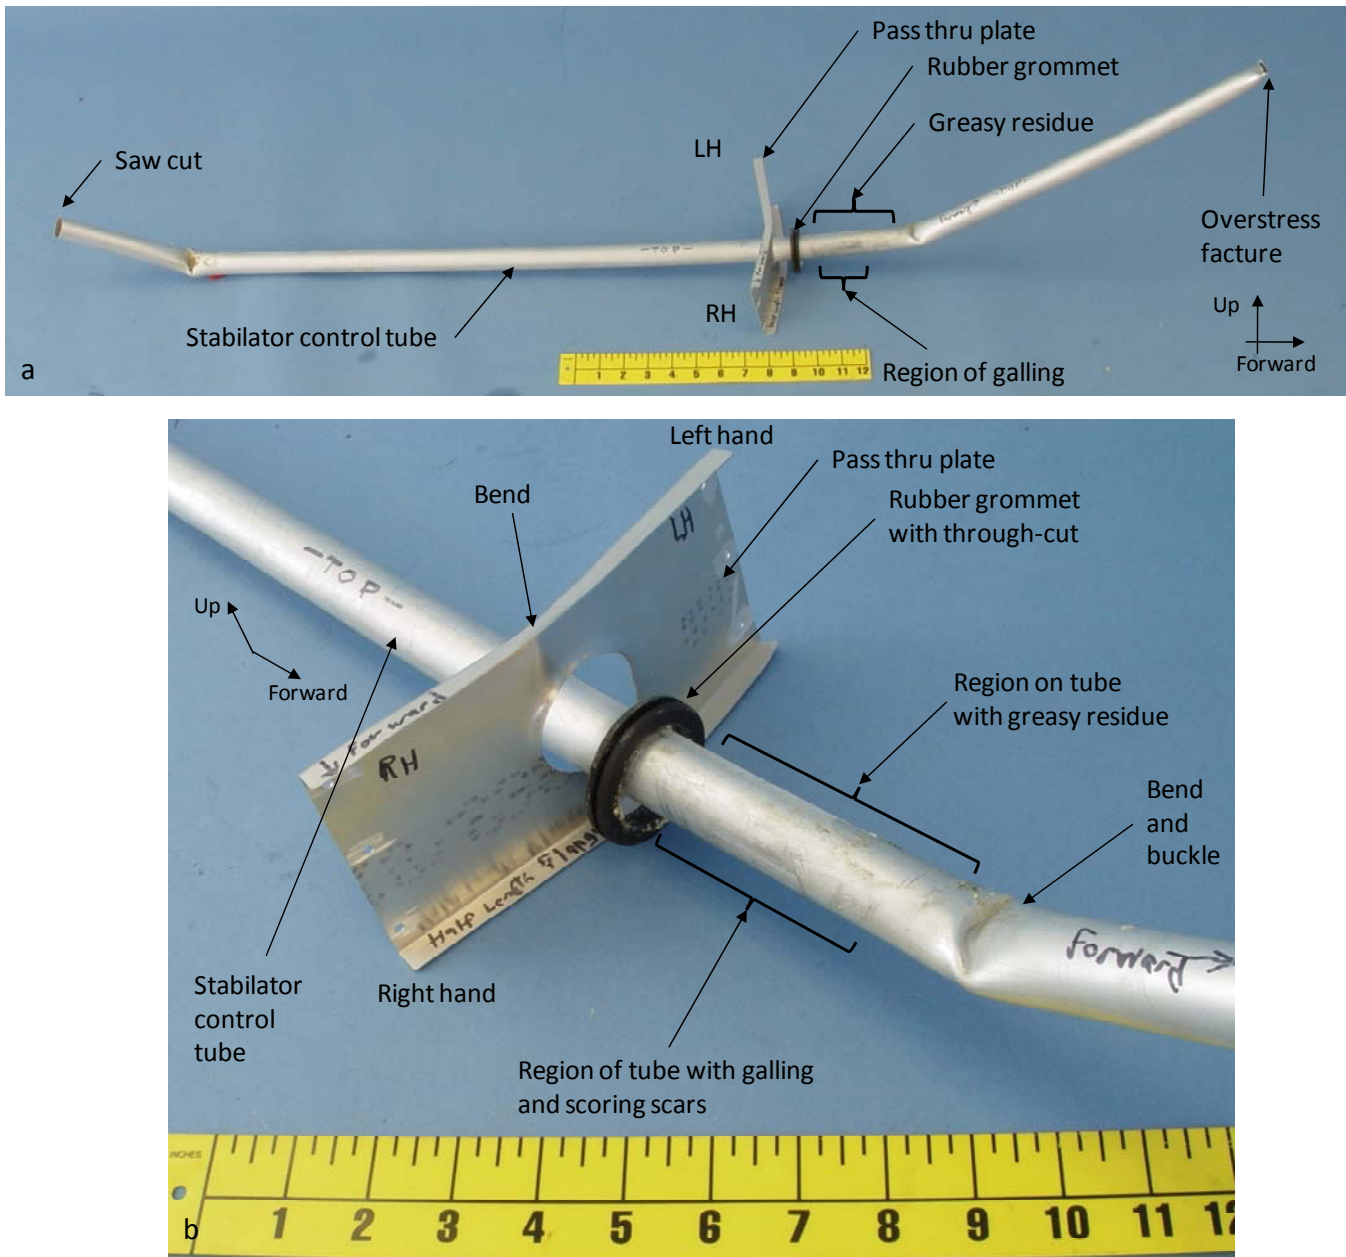
Photographs of the aft stabilator control tube assembled with the pass-thru plate are shown in Figure 6. As indicated in Figure 6a, the stabilator control tube piece is fractured at the forward end due to upward bending overstress, and is bent and buckled in two places along its length. Figures 6a and b indicate that the pass through plate is bent in the forward direction. The edge of the hole in the pass through plate is deformed in a manner

consistent with forward sliding contact with the stabilator control tube. The rubber grommet, which was once installed in the pass-thru plate hole (based on paint spatter and other fiducial marks), has a radial through-thickness cut in the wall. The radial cut in the grommet is consistent with the application of lateral force applied between the stabilator control tube and the pass-thru plate.

As indicated in Figure 6a and b, the surface of the stabilator has a thin, greasy residue in the region identified in Figure 6b. In this same region, the surface of the stabilator control tube exhibits features consistent with scoring and galling. Excrescence¹ features due to galling are consistent with forward sliding contact between the stabilator control tube and the edge of the pass-thru plate hole.

Figure 6 View (a) shows the overall stabilator control tube with key features. View (b) shows close up details of the stabilator control tube in relation to the pass thru plate.

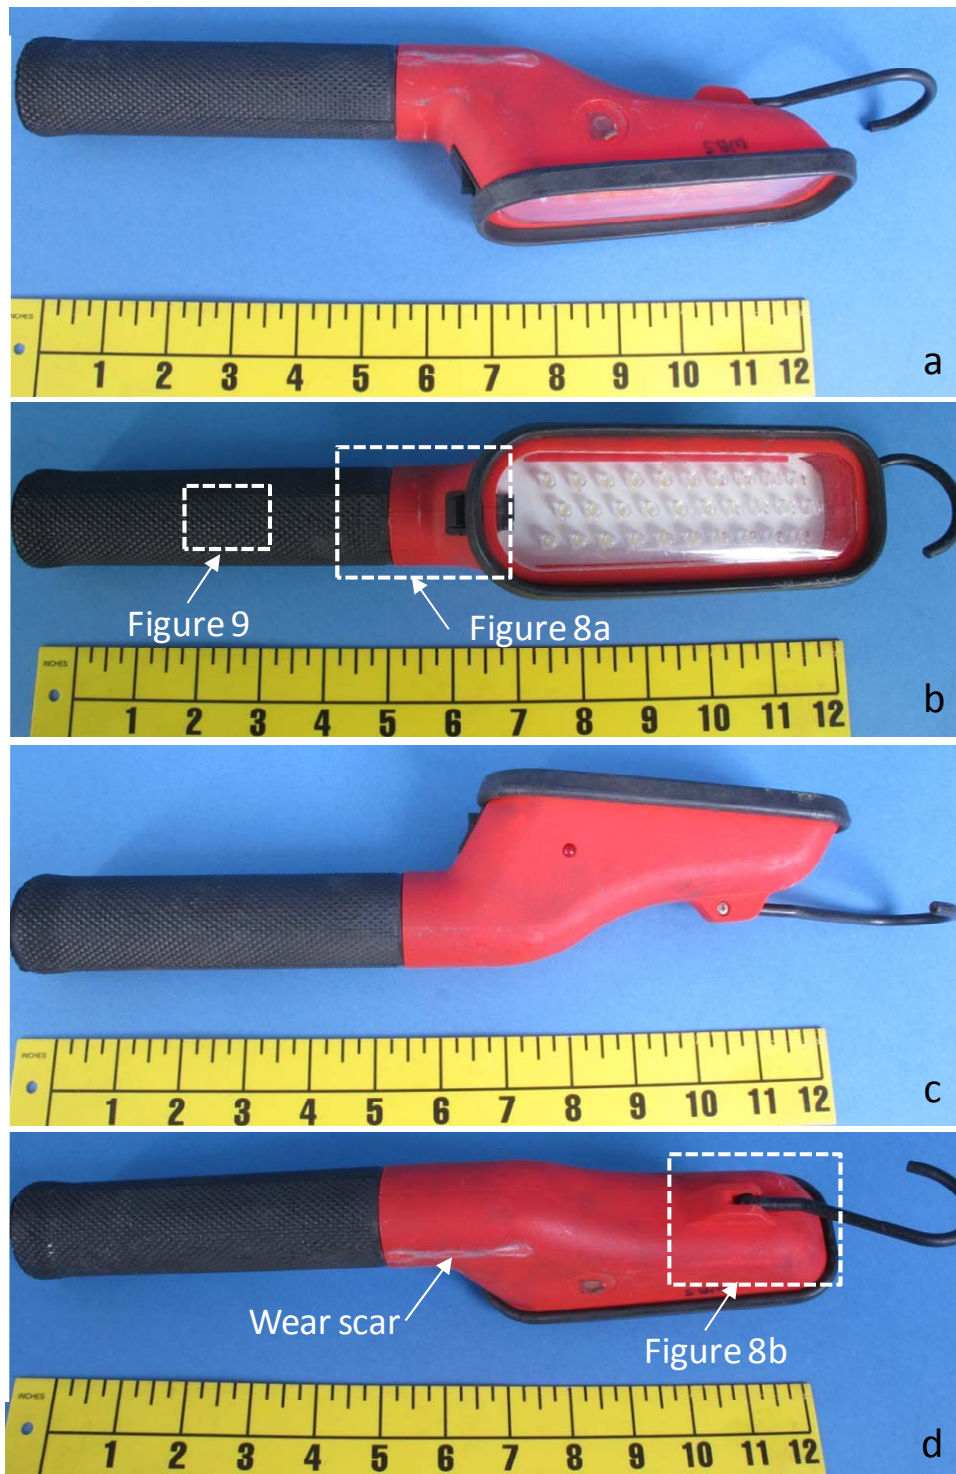
As indicated in Figure 1 and 3, a mechanic's work light was discovered within the tail section of the fuselage after the accident. Figure 7 shows views of the primary surfaces of the work light. There are no manufacturer marks on the exterior surfaces of the work light or under the rubber handle grip, which readily slides off the handle. The initials *WBS* are written on the side of the work light as shown in Figure 7a and on the back side of the handle under the rubber handle grip. A wear scar was observed on the side of the light as indicated in Figure 7d.

Figure 7 Views showing each side of the work light found in the fuselage tail section after the accident.

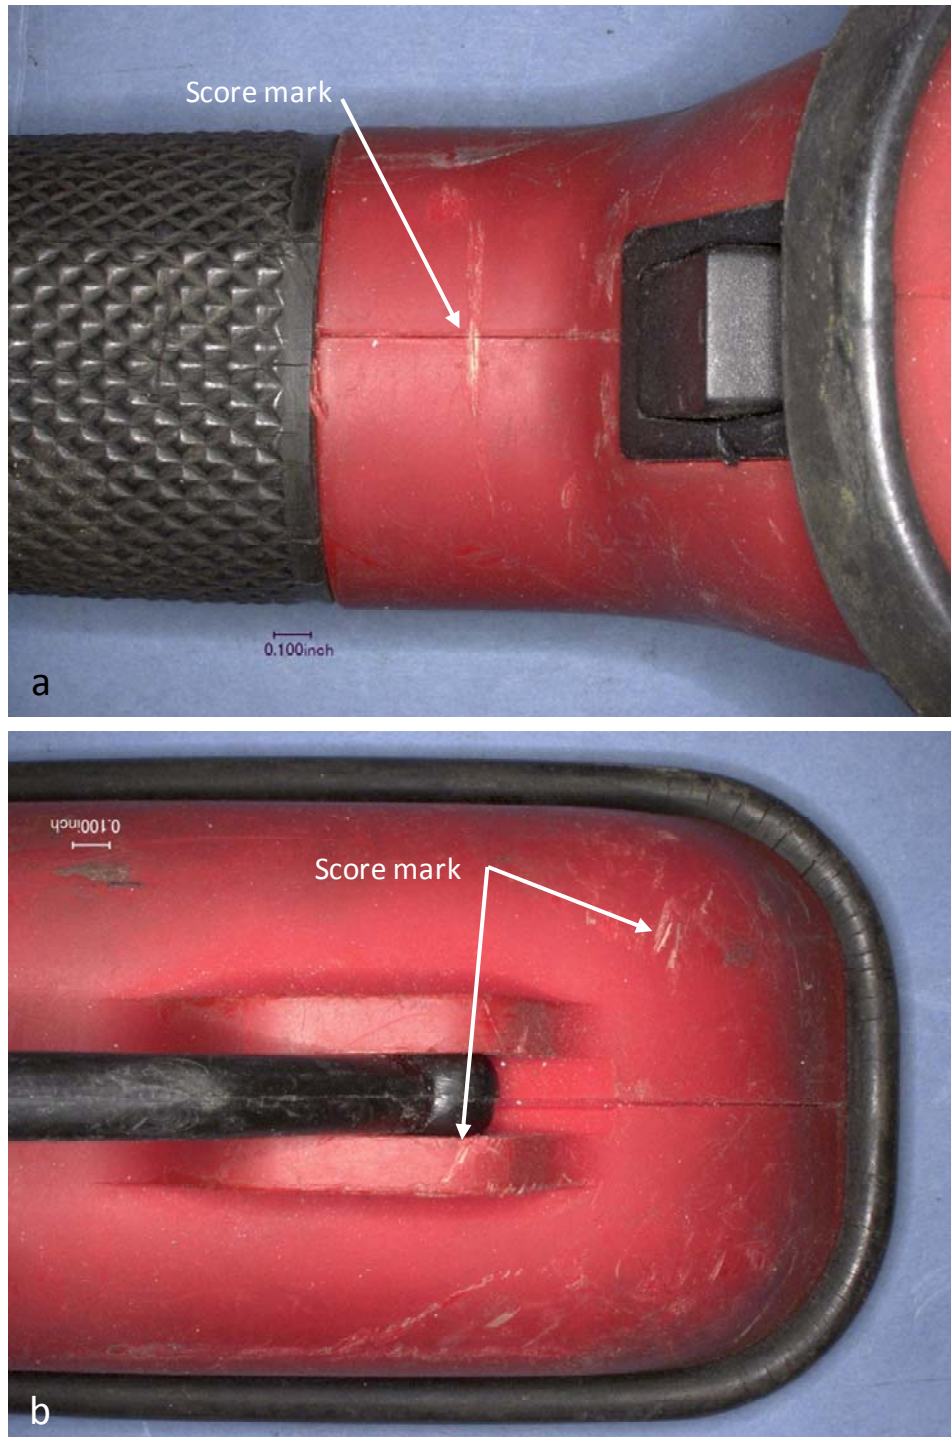
Figure 8a is closer view of the work light body adjacent to the on-off switch shown in Figure 7b. Between the switch and the rubber handle grip a score mark is present in the plastic work light body. This score mark is consistent with the body of the work light contacting a sharp edge or burr. Similar score marks are observed on the backside of the work light near the hook as indicated in Figure 7d and Figure 8b. Key feature dimensions of the repetitive diamond pattern on the rubber handle grip are indicated in Figure 7b and Figure 9.

Figure 8 View (a) is a close up of the switch region indicated in Figure 7 b showing a well defined score mark in the plastic housing just under the light switch.

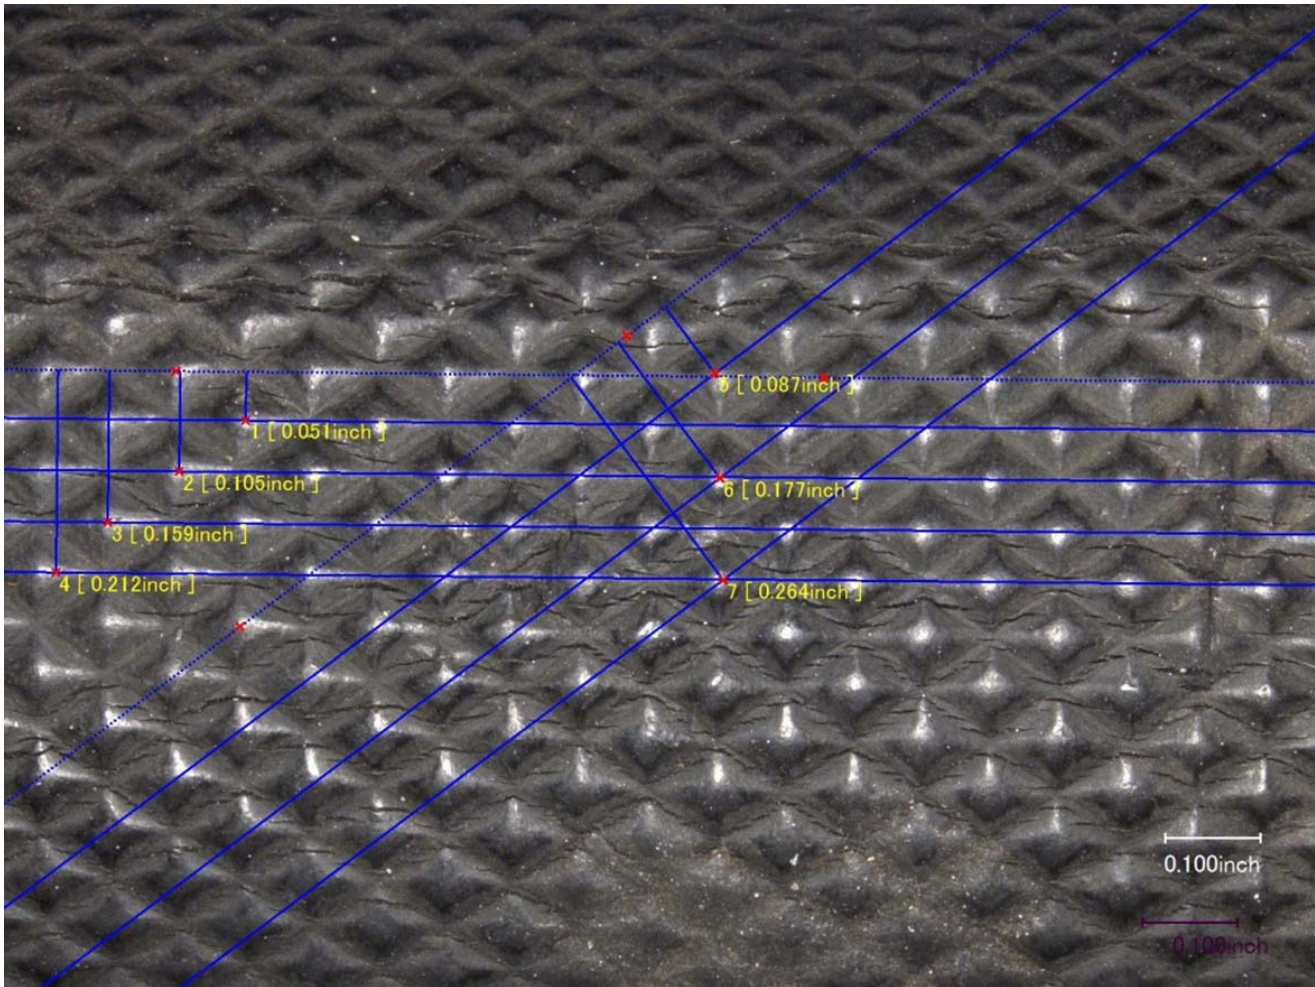
Figure 9 Close up view of the work light handle shown in Figure 7 b depicting key dimensions of the repetitive diamond grip features.

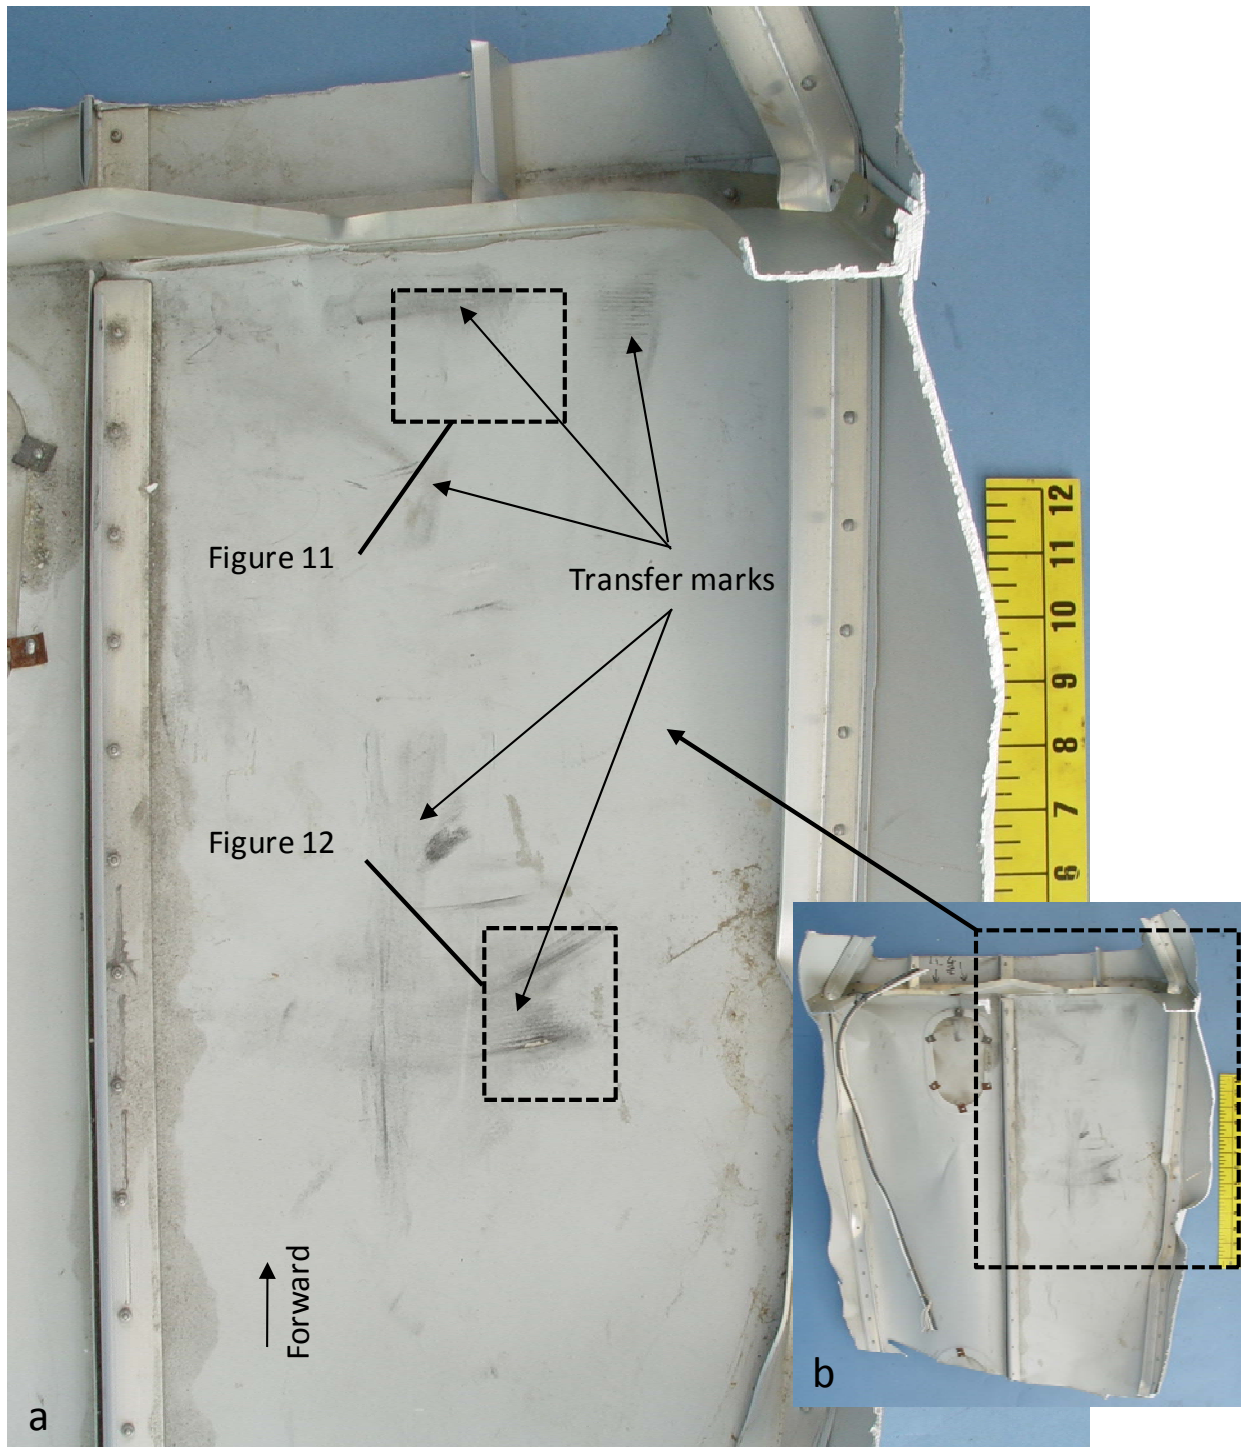
The bottom section of the fuselage tail (see Figures 2b and 5) was removed from the aircraft wreckage for closer examination. A closer view of the bottom piece is shown in Figure 10a. Black marks (referred to as transfer marks in this report) are present in various areas on the inner surface of the bottom piece of fuselage tail as indicated in Figure 10. Under optical microscopic examination, the black transfer marks are consistent with tribo-transfer of material from the work light's black rubber handle grip. Figures 11 and 12 are optical microscope images of two regions exhibiting black transfer marks. In Figure 11a, the image is digitally altered to enhance the contrast between the transfer marks and the as-primed surface of the inner fuselage. Features consistent with the repetitive diamond pattern on the mechanic's work light rubber handle grip are present on the inner fuselage surface. Measurement of these specific transfer marks is shown in Figure 11b. A sketch in Figure 12 shows the key dimensions of the diamond features. A table in Figure 13 summarizes the key dimensions of the diamond pattern of the work light handle grip and the black transfer marks on the inner bottom surface of the fuselage. Based on the key

Figure 10 Internal surface of the bottom of the fuselage tail section right and aft of the bulkhead containing the stabilator control tube pass-thru plate. A plurality of black transfer marks are noted on the surface.

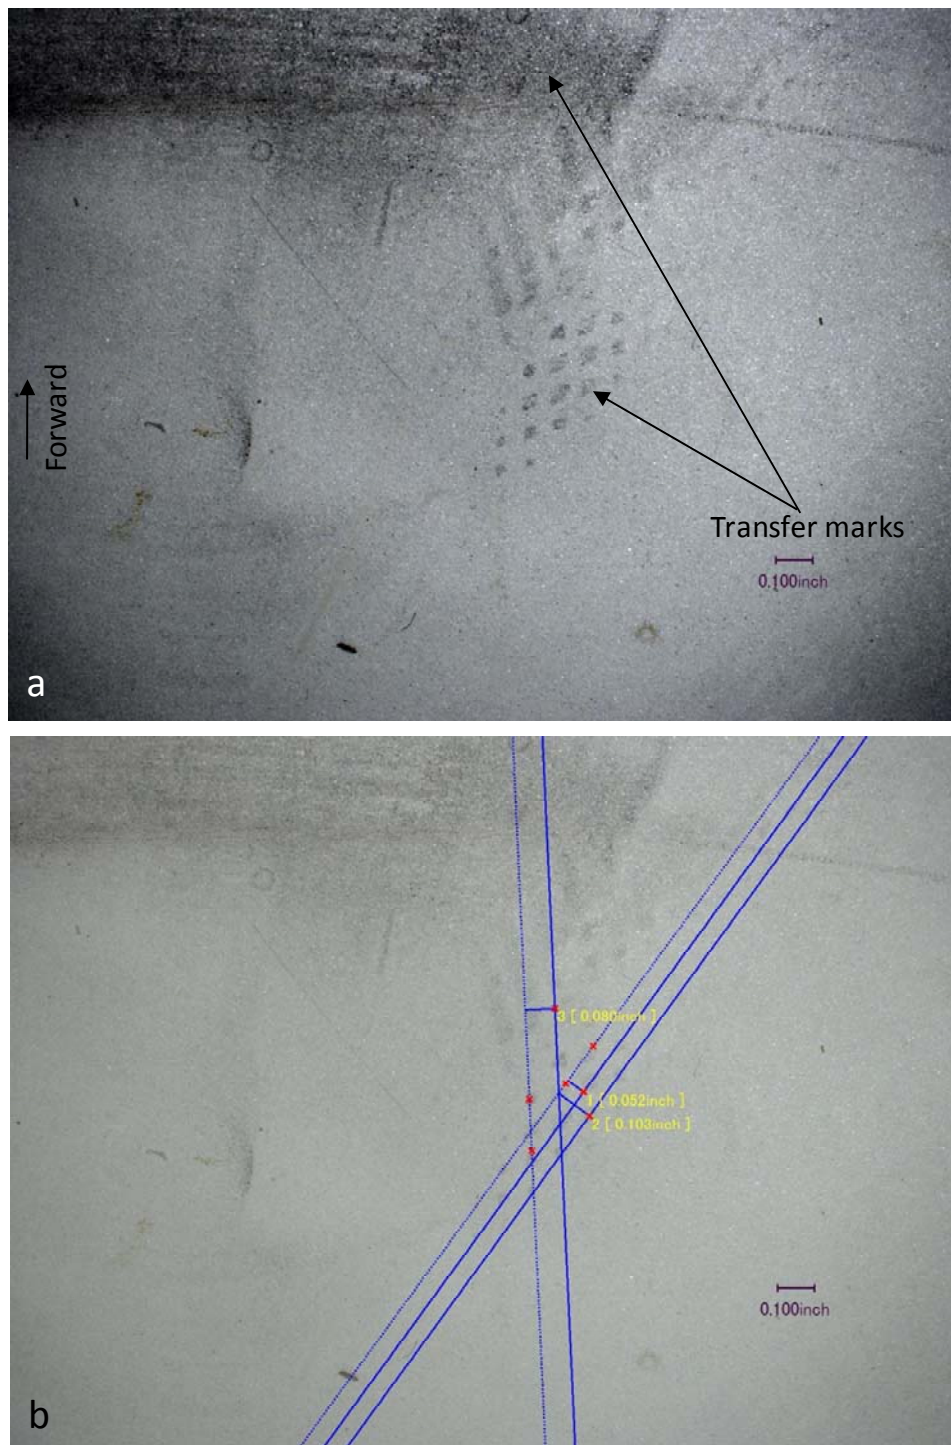
dimensional measurements, it appears that the black transfer marks on the inner bottom surface of the fuselage tail section are consistent with marks made by the work light's rubber handle grip.

Figure 11 Close up image of the transfer mark indicated in Figure 10. View (a) is digitally enhanced to reveal diamond patterns in the transfer marks. View (b) shows the key dimensions of the diamond patterns in the transfer marks.

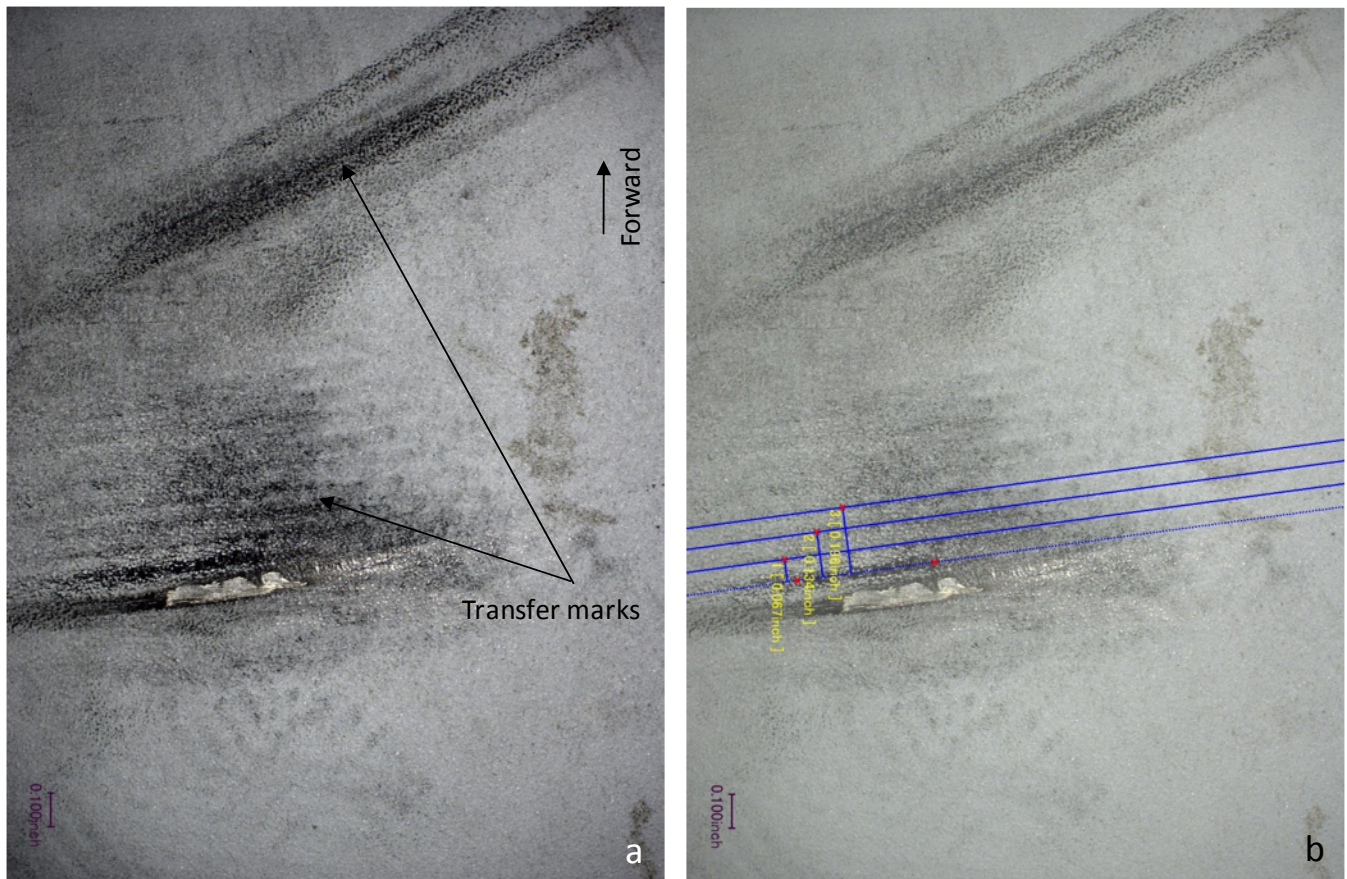
Figure 12 Close up image of the transfer mark indicated in Figure 10. View (a) is digitally enhanced to reveal diamond patterns in the transfer marks. View (b) shows the key dimensions of the diamond patterns in the transfer marks.

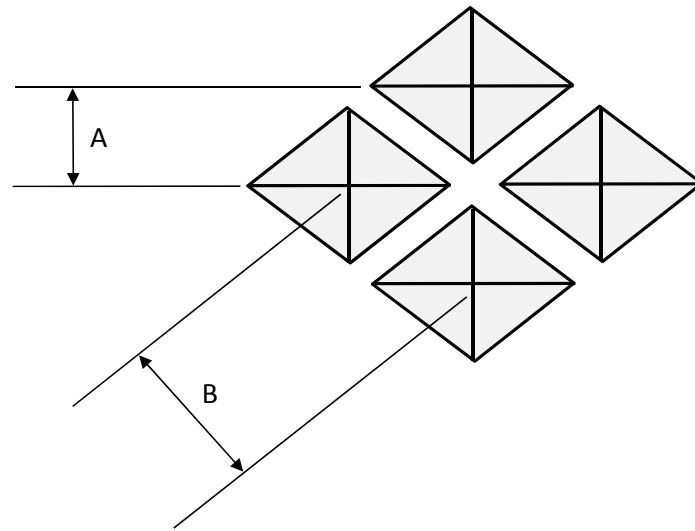
A (inch)	B (inch)
Work light grip pattern (Figure 9)	0.052	0.080
Transfer marks (Figure 11)	0.053	0.088

Figure 13 A sketch of the repetitive diamond pattern on the work light handle and a summary of the key dimensions from the transfer marks in Figure 11 and the work light grip pattern in Figure 9.
